**Staff Report to the Building Fire Code Commission  
Schofield Building-600 Main Street  
Owner's request for unfit determination and demolition per VMC 17.32**

<b>Report Date</b>	October 28, 2024
<b>Hearing Date</b>	October 30, 2024
<b>Buildings/Location</b>	600-604 Main Street. Parcel ID 47950000
<b>Property Owner</b>	Schofield Properties 600 Main St LLC
<b>Staff</b>	Sree Thirunagari, Building Official Jeri Newbold, ABO/Code Compliance Manager Lauren DiPalma, Plan Review Supervisor/Staff Engineer
<b>Applicable codes</b>	VMC Chapter 17.32 Unfit Buildings and Premises Code VMC Chapter 20.510 Heritage Overlay District- demolition process and steps

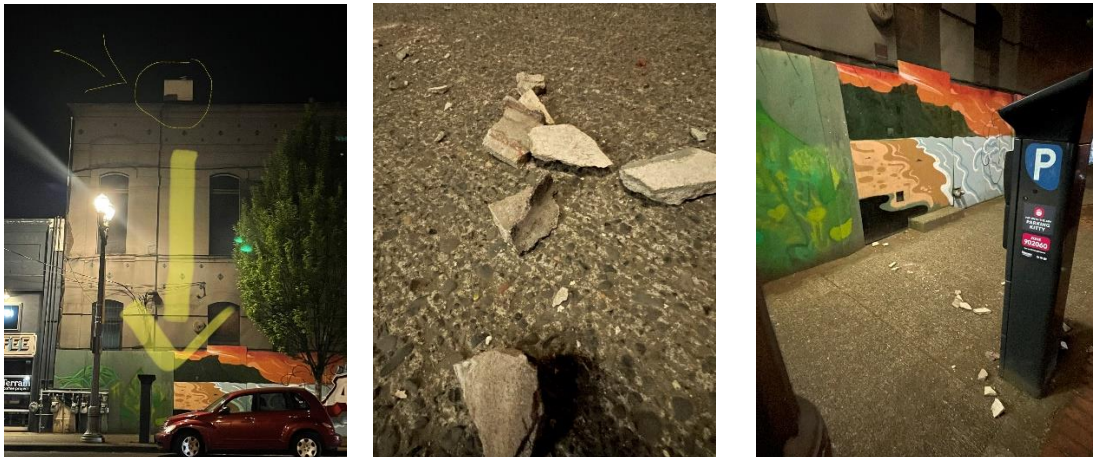
(Photos from email on 4/25/24)

City of Vancouver Code Compliance was copied on an email from the Chief Building Official, Sree Thirunagari on Thursday 4/25/24 regarding the building located at 600 Main Street. Some loose plaster from the chimney had fallen on the sidewalk on 4/23/24 and was reported to the City of Vancouver.

A code case was opened (CDE-89087) but at this time the Chief Building Official had already contacted representatives for the building and instructed them to remove all loose plaster and install netting around the chimney to prevent any further incidents until a more detailed evaluation could be made.

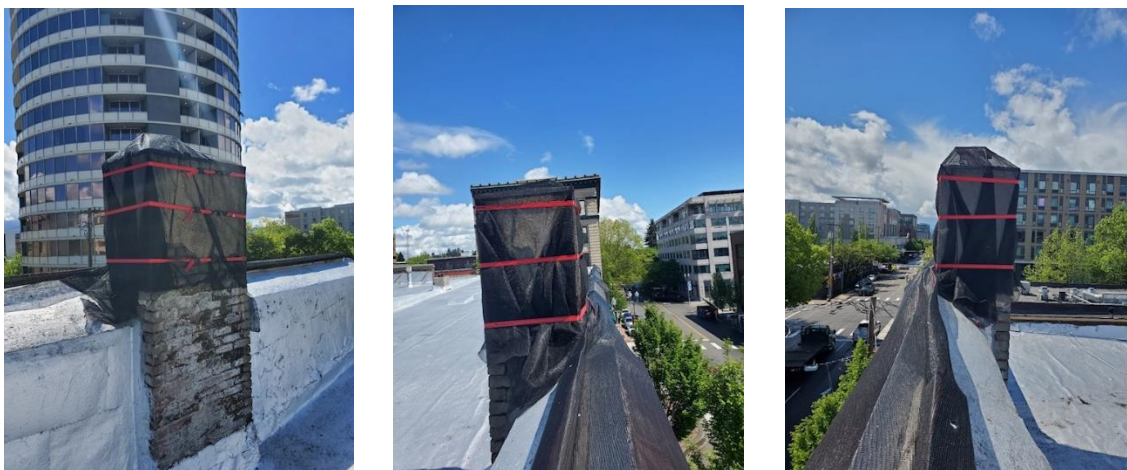
(Photos from email on 4/29/24)

Code compliance received an email from April Velilla on Monday 4/29/24 indicating the work has been completed and photos were attached.

After reviewing the photos with the Chief Building Official, it was determined that the code case would be closed and the building owners would be meeting with city staff to determine the next steps.

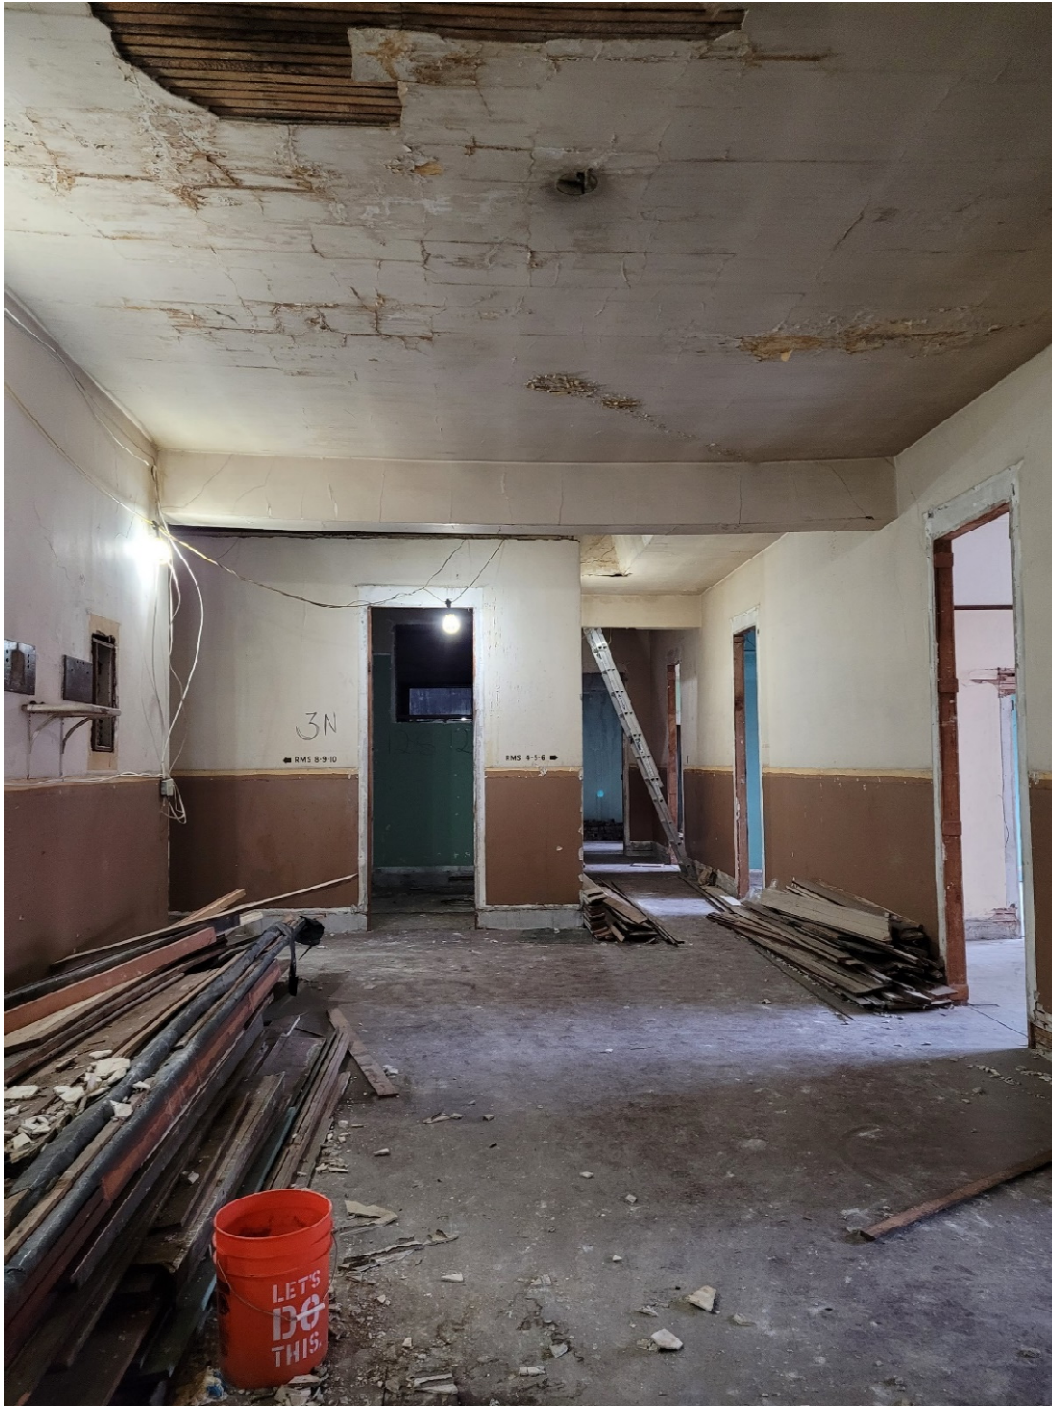
VMC items C.1, I.1, and J

The roof structure has excessive deflection with damage to the plaster. This occurs over unoccupied space and is susceptible to failure at a code level snow event.

Photo looking north.

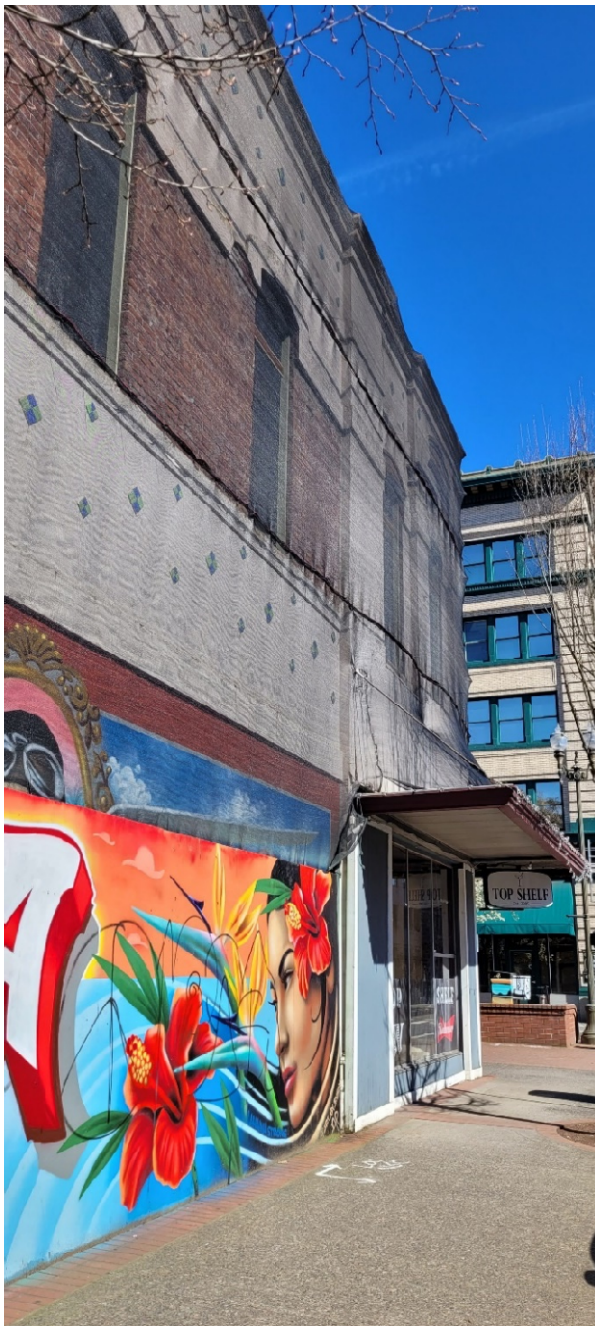
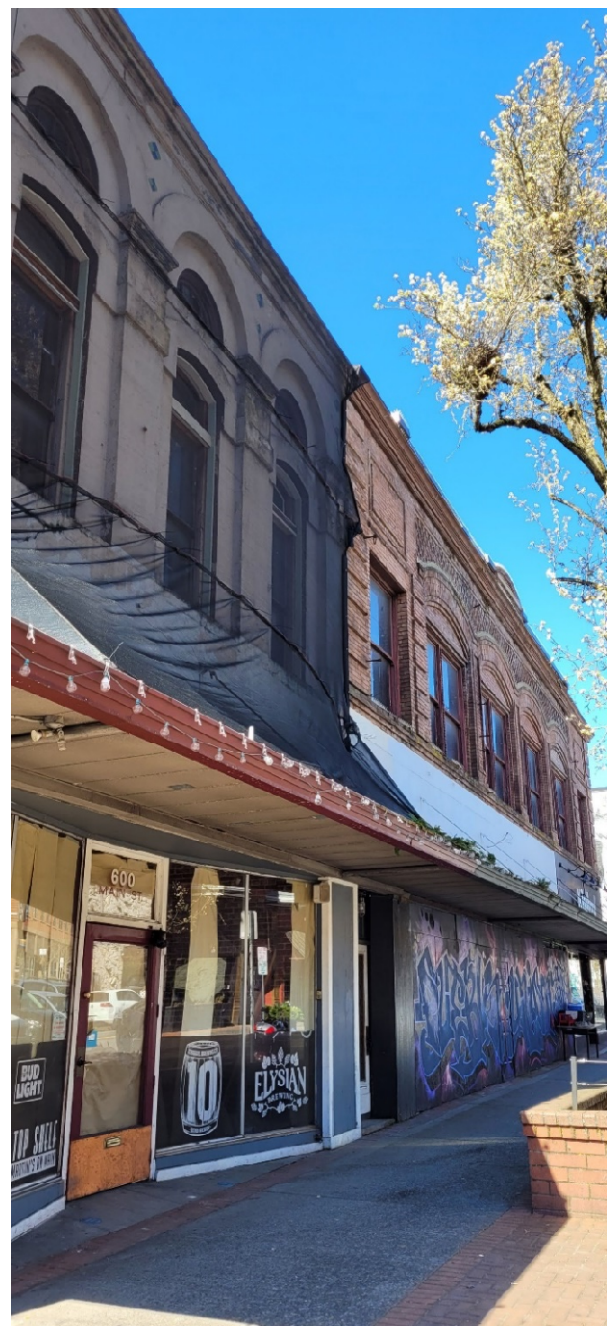
VMC items F.3, F.5 G.3, G.4, and L.1

The exterior stucco of the building is losing adhesion to the unreinforced masonry exterior wall and is falling off the building. This condition currently has a netting to keep the stucco from falling onto the sidewalk. The exterior canopy and its attachment to structure is also pictured.

Photos of the south (left) and east (right) exterior.

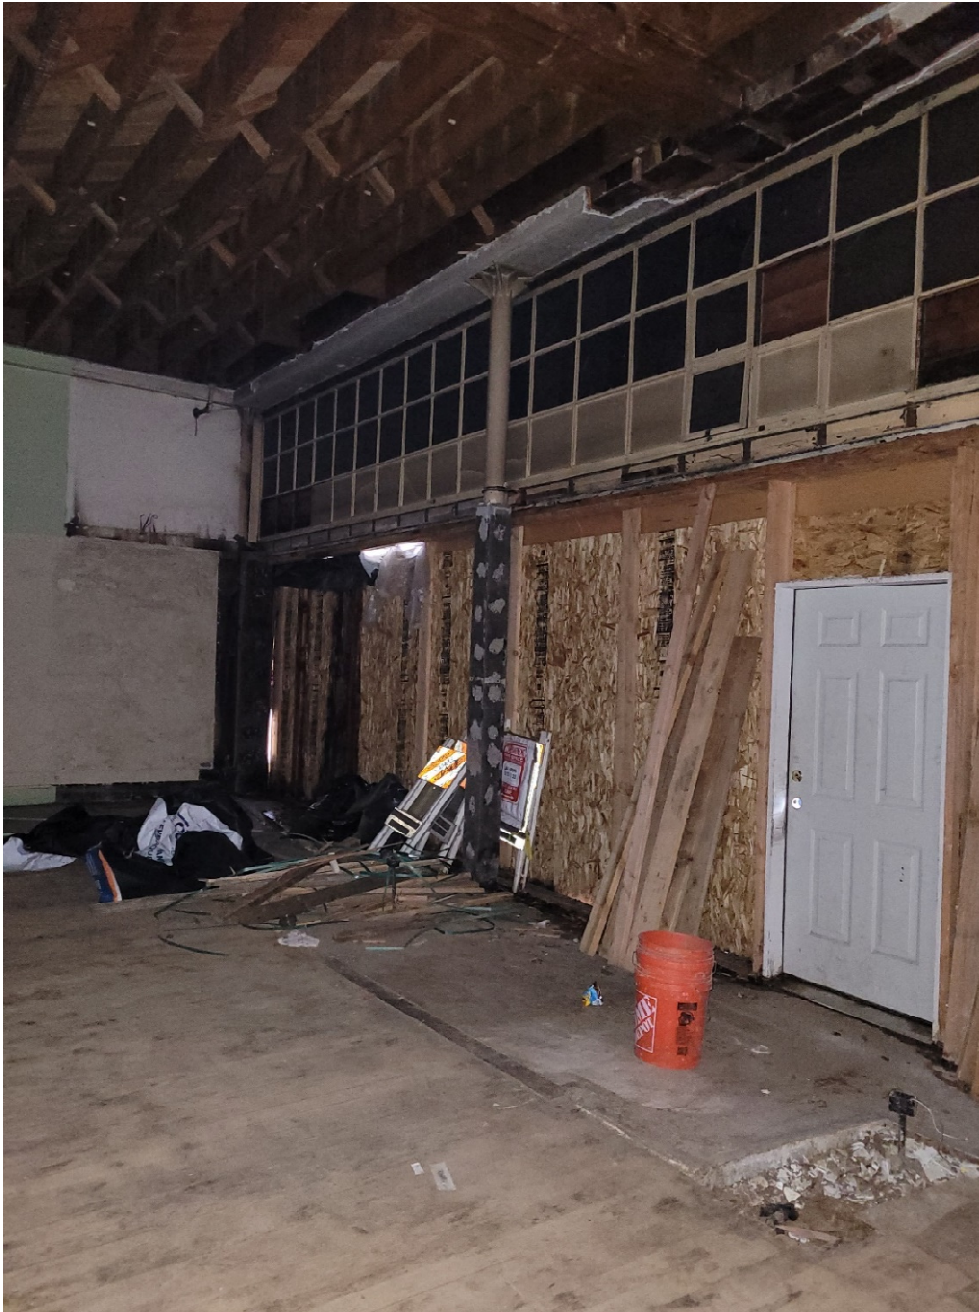
VMC items F.6, G.5, I.3, K, and L.2

East storefront at the unoccupied space is currently unsecured and unsupported and is covered with a temporary wall.

Photo looking to the east.

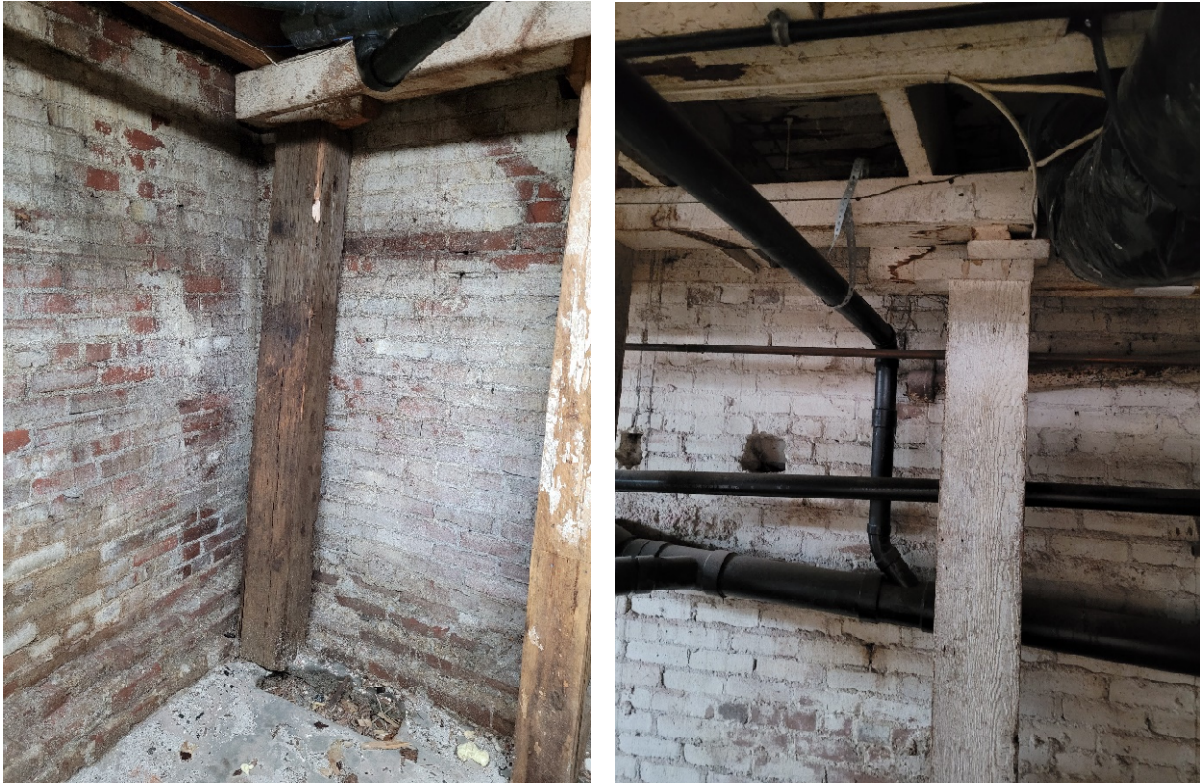
VMC items F.4, I.2, and K

The post and beam structure supporting the first-floor framing is warped/leaning and does not have positive attachment to the framing or the foundation.

Photos in the basement. This is the southern most un-occupied space.

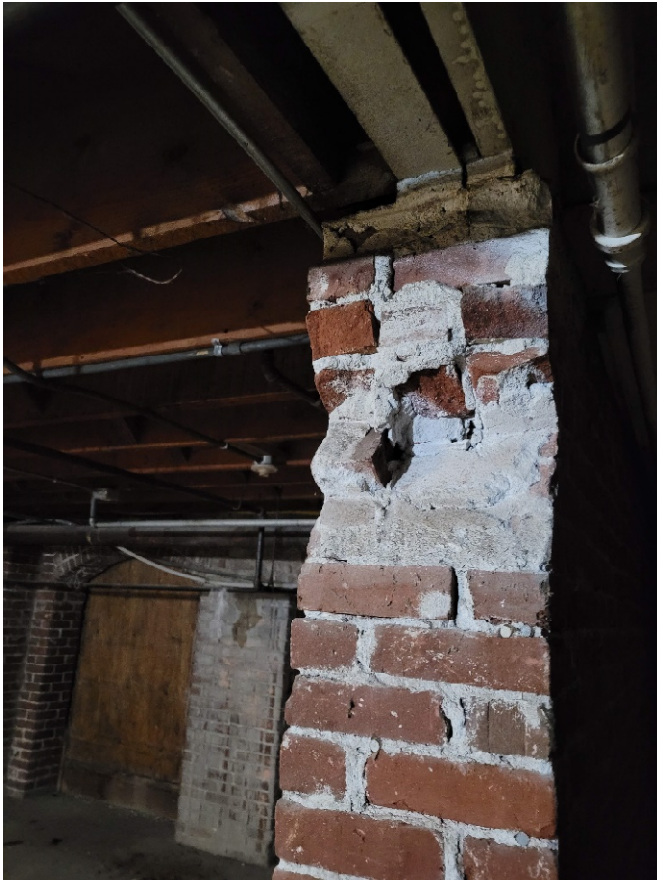
VMC item I.4

The basement foundation walls are unreinforced masonry. Some of the walls have observed damage. The exterior basement walls are retaining soil and exterior sidewalks. The east basement walls have openings that are filled in with plywood to support retain the soil.

Photo of damage looking to the east.

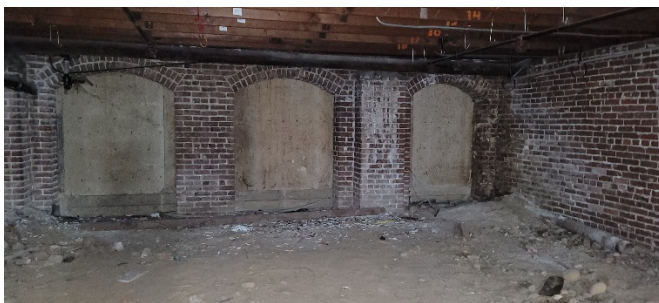
Photo looking to the east of basement walls with openings and plywood.
