## Building/Fire Code Board Meeting Agenda

# SCHOFIELD BLOCK

BUILDING AND FIRE CODE COMMISSION MEETING

## STAFF REPORT

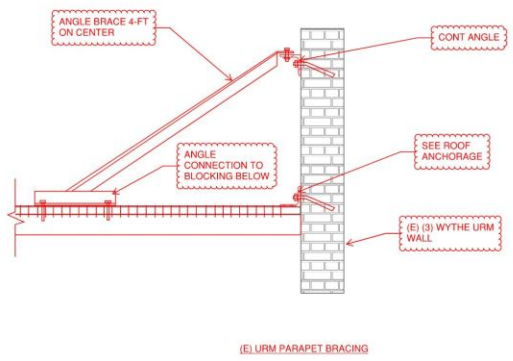
| ITEM | CODE | SCOPE | FIX | COST |
|---|---|---|---|---|
| UNREINFORCED MASONRY<br>UNBRACED PARAPETS | VMC 17.32.040 F<br>(ITEM F.2 IN REPORT)<br><br>VMC 17.32.040 G<br>(ITEM G.2 IN REPORT)<br><br>17.32.020 | <p>EXISTING PARAPETS ARE BRACED FOR A PORTION</p> <p>2399 SF</p> <p>3798 SF</p> <p>1755 SF</p> <p>65'-0"</p> <p>PARAPET SCOPE:<br/>65'-FT OF ROOF</p> | <p>ANGLE BRACE 4-FT ON CENTER</p> <p>ANGLE CONNECTION TO BLOCKING BELOW</p> <p>SEE ROOF ANCHORAGE</p> <p>CONT ANGLE</p> <p>(E) (3) WYTHE URM WALL</p> <p>(E) URM PARAPET BRACING</p> | \$375,535.00 |

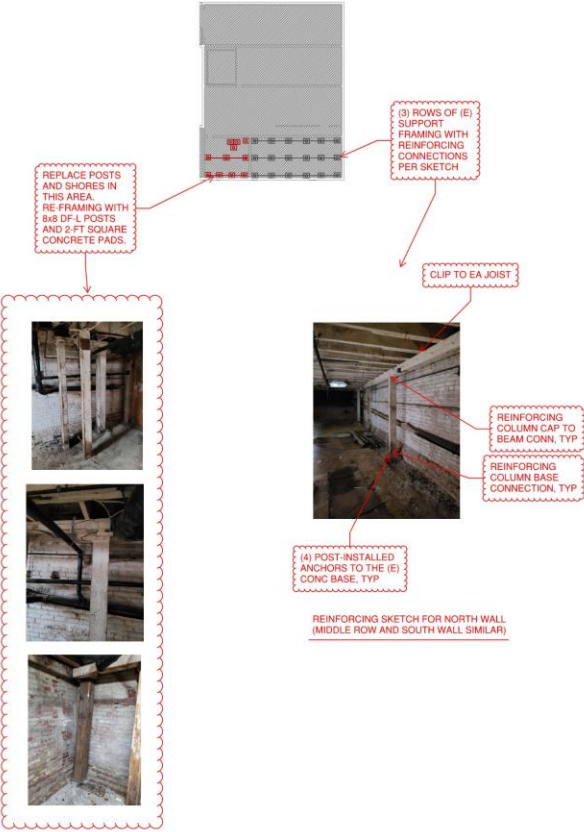
| ITEM | CODE | SCOPE | FIX | COST |
|---|---|---|---|---|
| GROUND FLOOR<br>SUPPORT FRAMING | VMC 17.32.040 F<br>(ITEM F.4 IN REPORT) | <div><p>23% OF THE GROUND FLOOR</p></div> | <div><p>REPLACE POSTS AND SHORES IN THIS AREA. RE-FRAMING WITH 8x8 DF-L POSTS AND 2-FT SQUARE CONCRETE PADS.</p><p>(3) ROWS OF (E) SUPPORT FRAMING WITH REINFORCING CONNECTIONS PER SKETCH</p><p>CLIP TO EA JOIST</p><p>REINFORCING COLUMN CAP TO BEAM CONN. TYP</p><p>REINFORCING COLUMN BASE CONNECTION, TYP</p><p>(4) POST-INSTALLED ANCHORS TO THE (E) CONC BASE, TYP</p><p>REINFORCING SKETCH FOR NORTH WALL (MIDDLE ROW AND SOUTH WALL SIMILAR)</p></div> | \$325,000.00 |

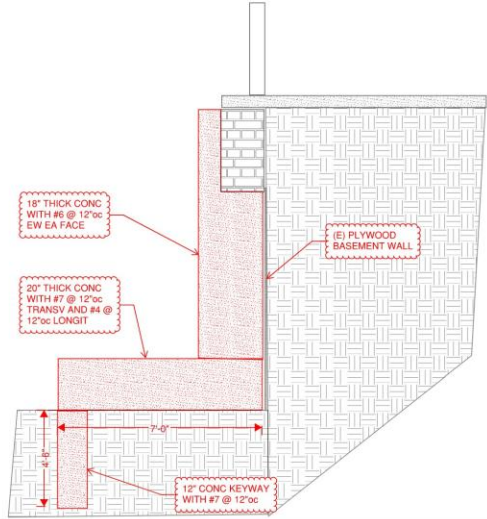
| ITEM | CODE | SCOPE | FIX | COST |
|---|---|---|---|---|
| PLYWOOD BASEMENT WALLS | VMC 17.32.040 I<br>(ITEM I.4 IN REPORT) | | | \$89,000.00 |

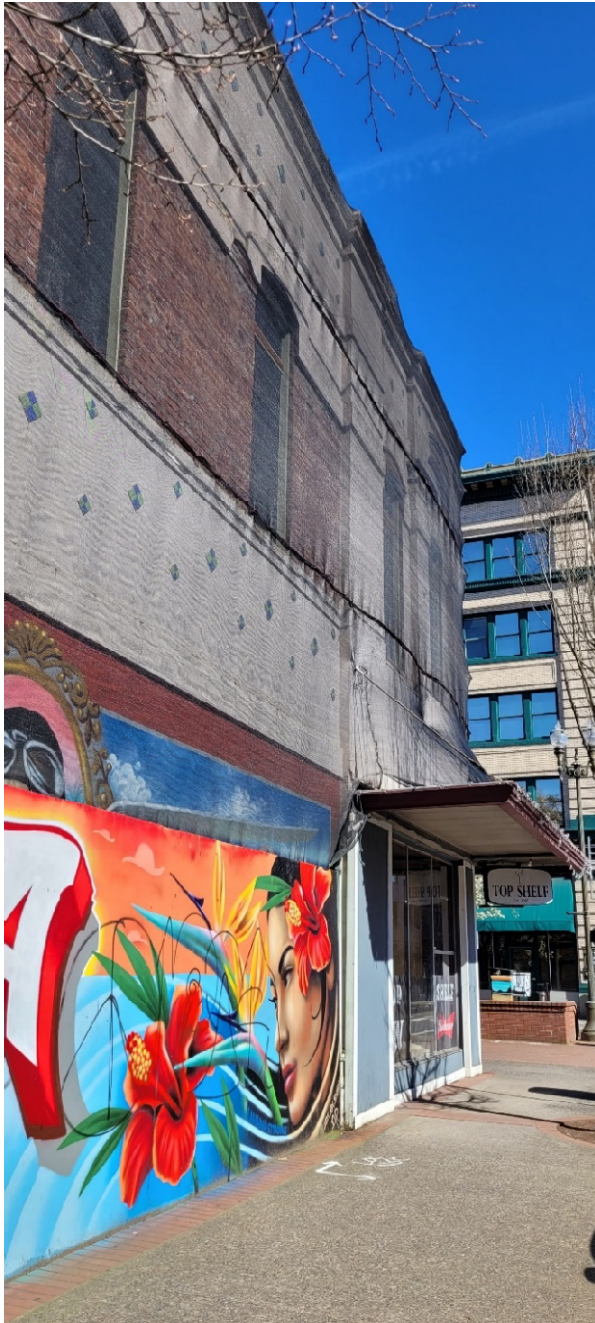
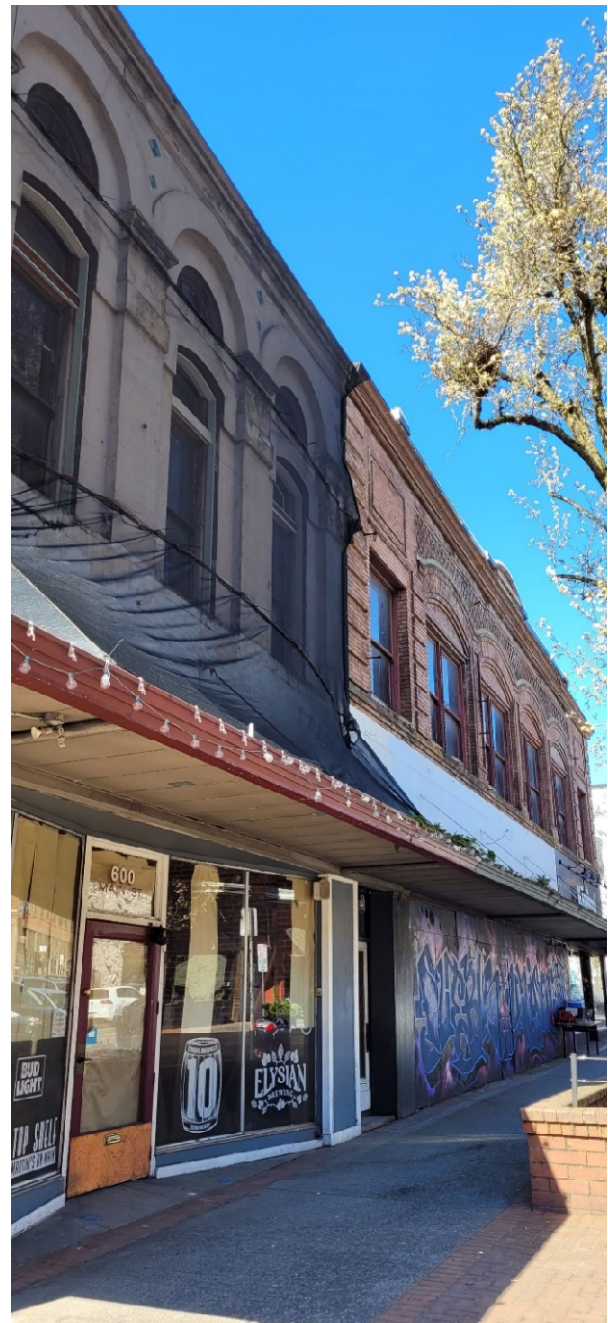
VMC items F.3, F.5 G.3, G.4, and L.1

The exterior stucco of the building is losing adhesion to the unreinforced masonry exterior wall and is falling off the building. This condition currently has a netting to keep the stucco from falling onto the sidewalk. The exterior canopy and its attachment to structure is also pictured.

Photos of the south (left) and east (right) exterior.

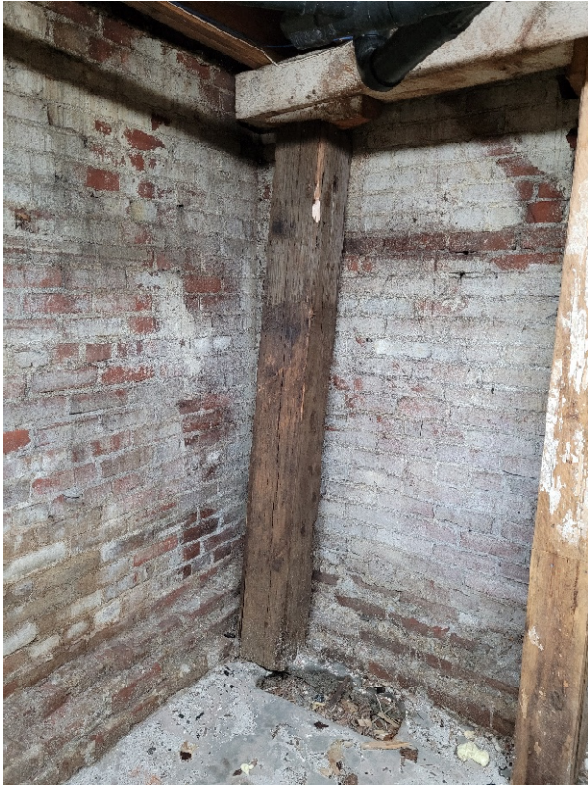
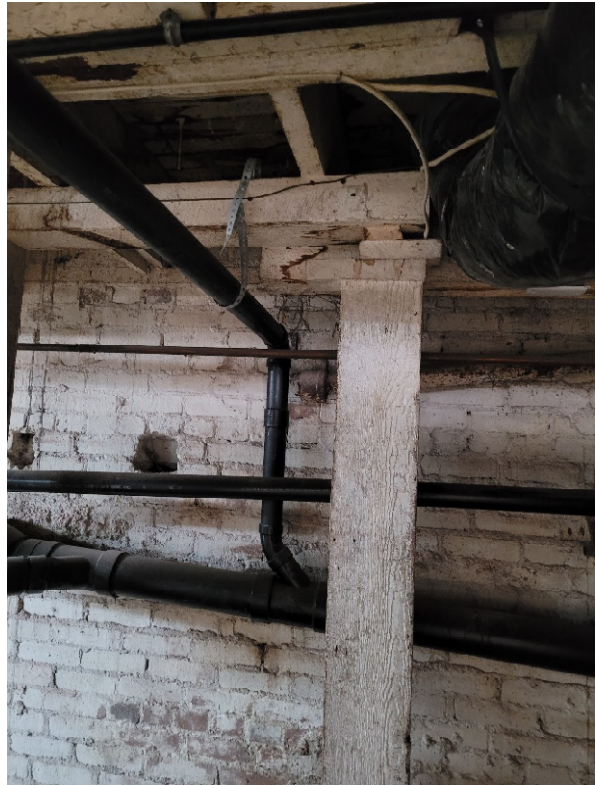
VMC items F.4, I.2, and K

The post and beam structure supporting the first-floor framing is warped/leaning and does not have positive attachment to the framing or the foundation.

Photos in the basement. This is the southern most un-occupied space.

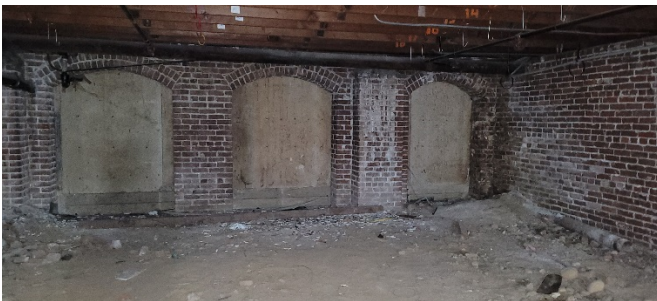
Photo looking to the east of basement walls with openings and plywood.

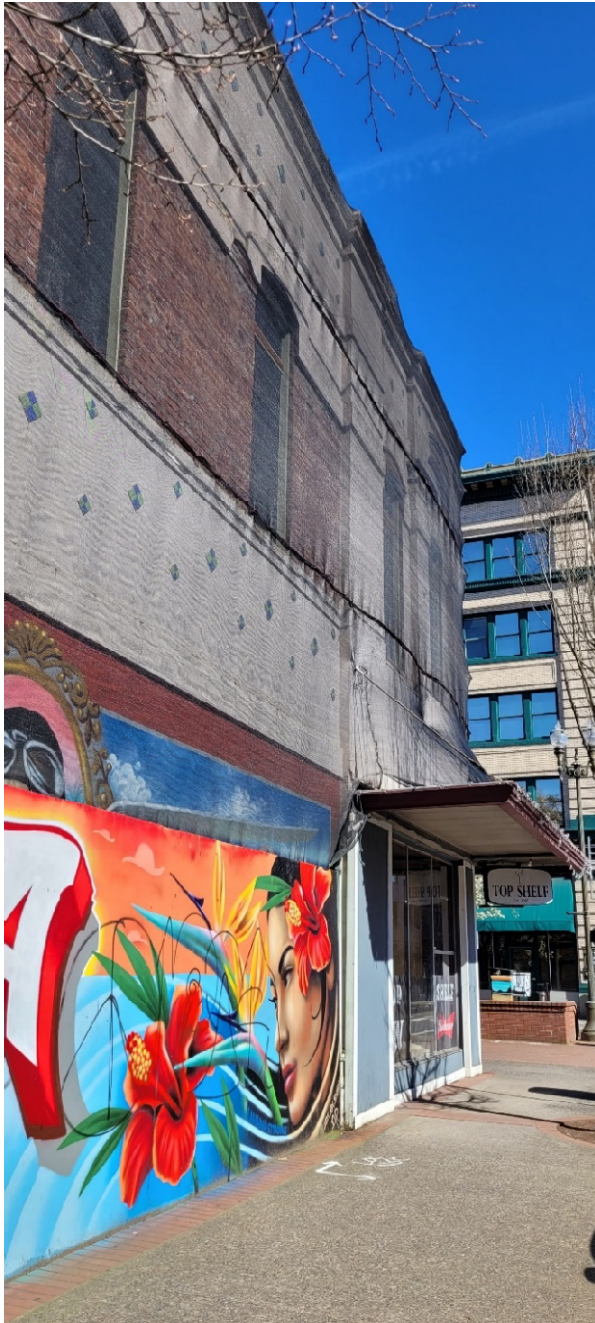
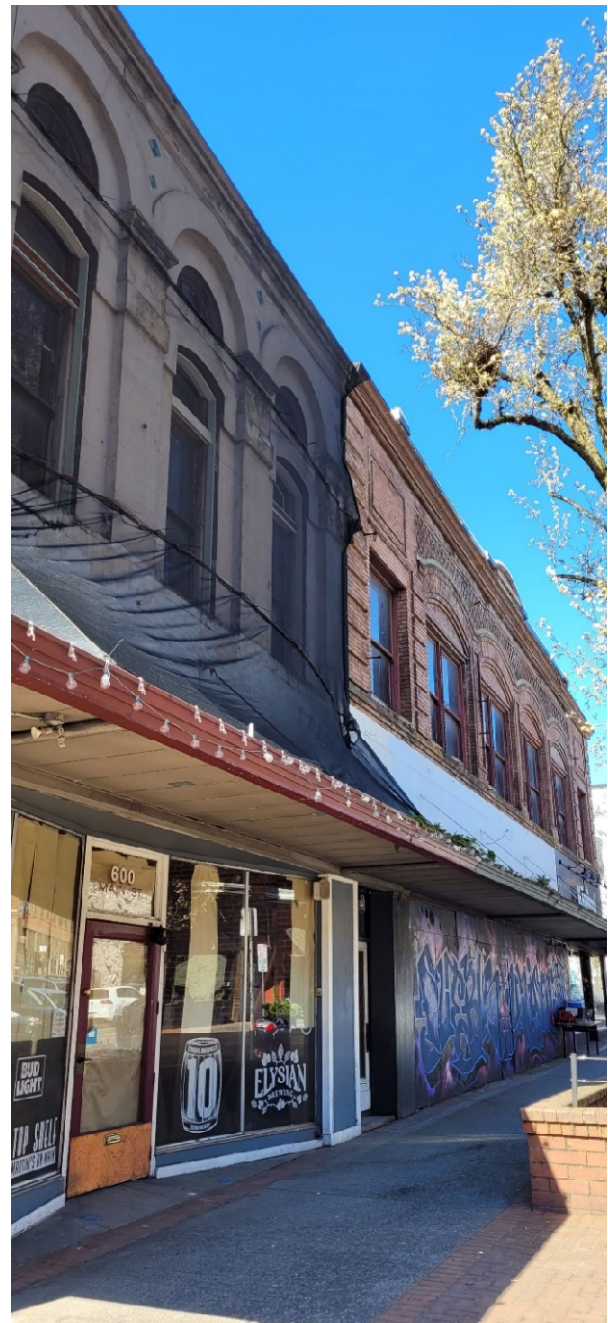
VMC items F.3, F.5 G.3, G.4, and L.1

The exterior stucco of the building is losing adhesion to the unreinforced masonry exterior wall and is falling off the building. This condition currently has a netting to keep the stucco from falling onto the sidewalk. The exterior canopy and its attachment to structure is also pictured.

Photos of the south (left) and east (right) exterior.

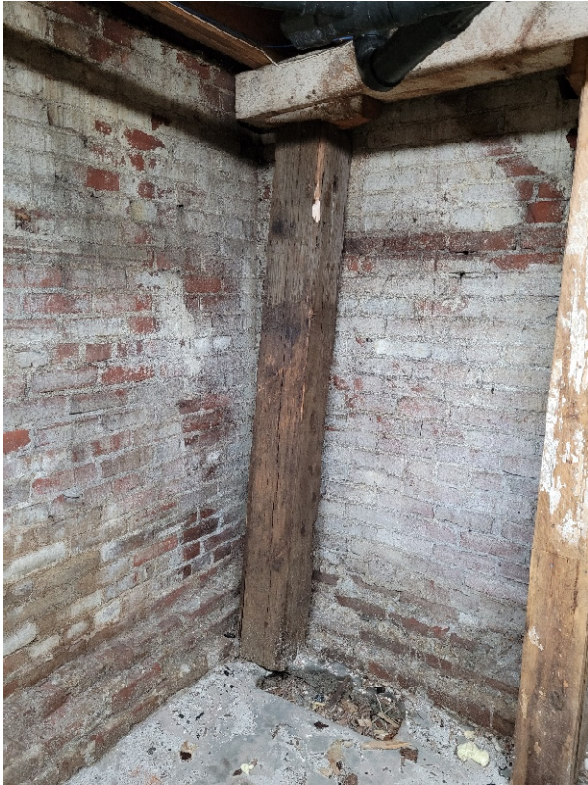
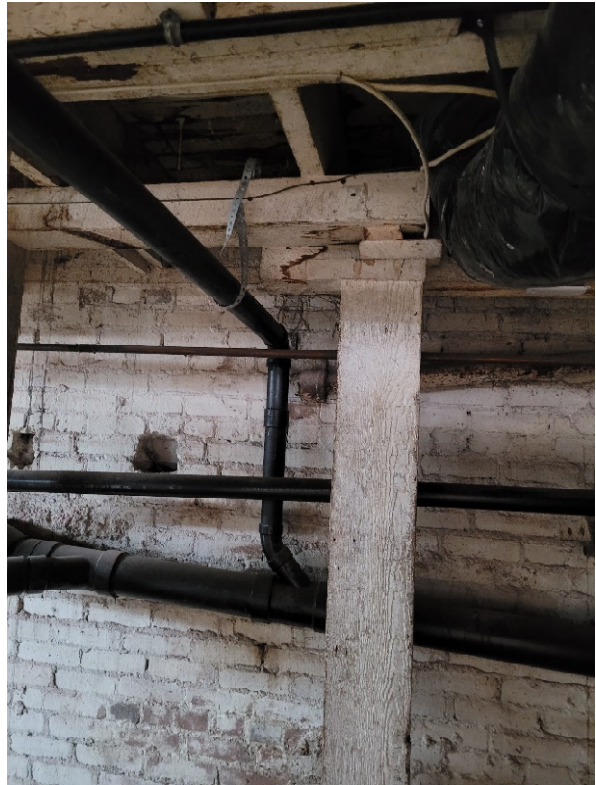
VMC items F.4, I.2, and K

The post and beam structure supporting the first-floor framing is warped/leaning and does not have positive attachment to the framing or the foundation.

Photos in the basement. This is the southern most un-occupied space.

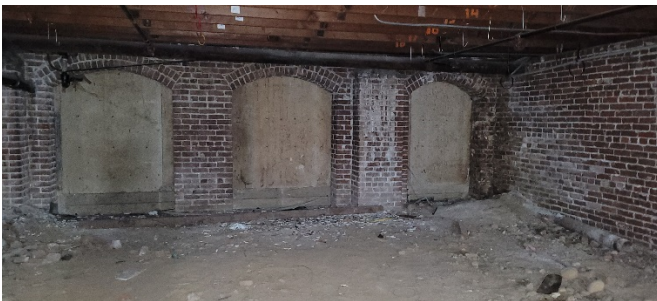
Photo looking to the east of basement walls with openings and plywood.

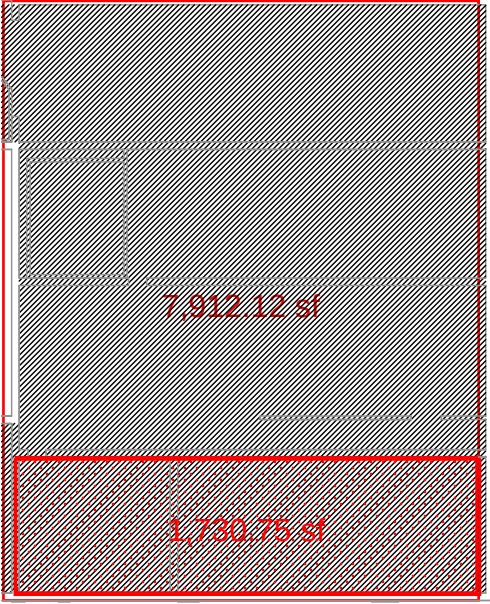
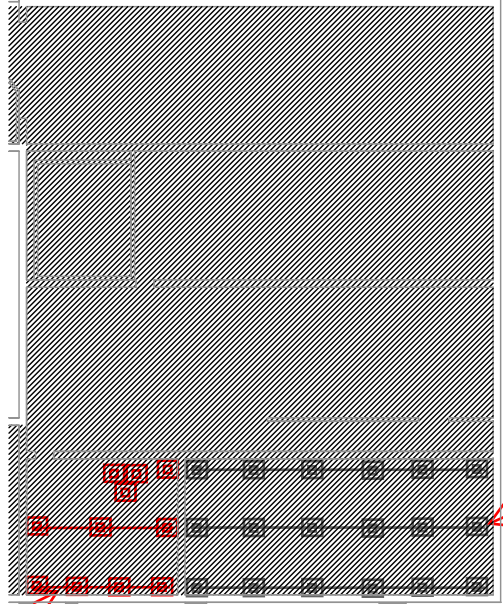
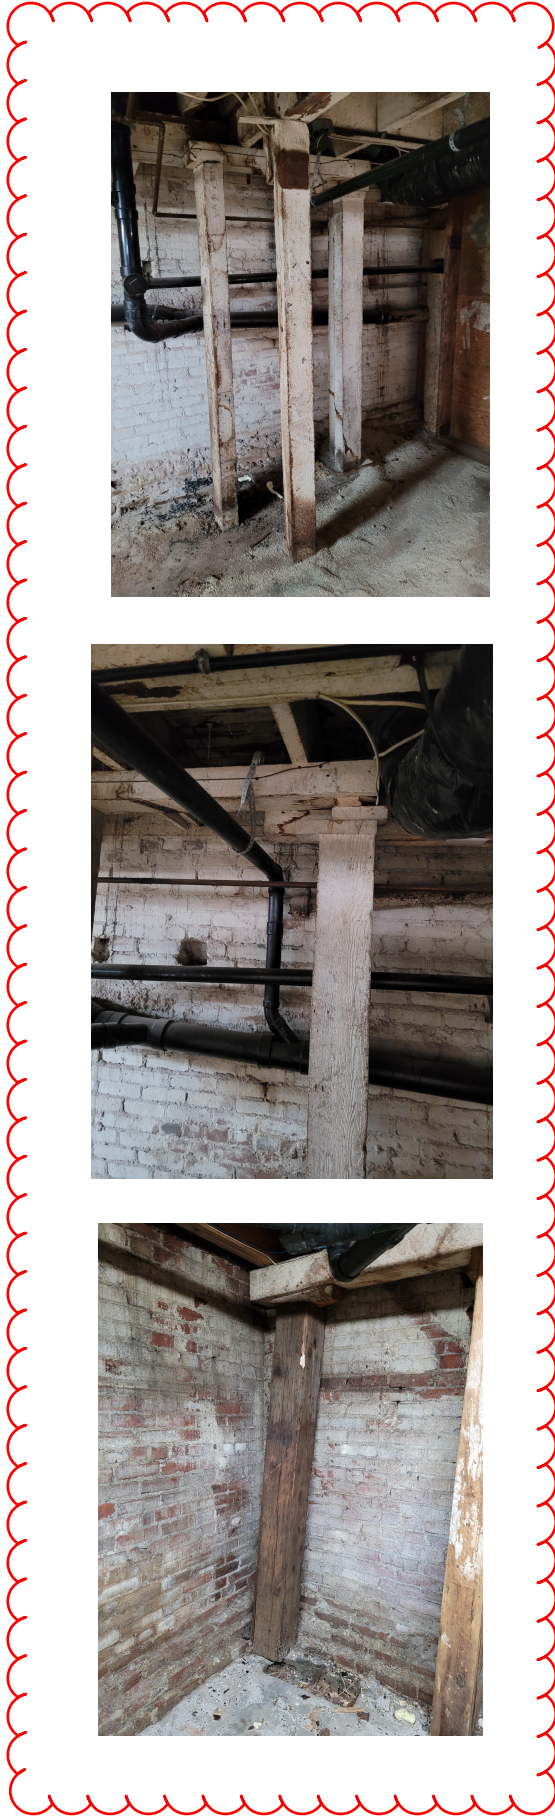
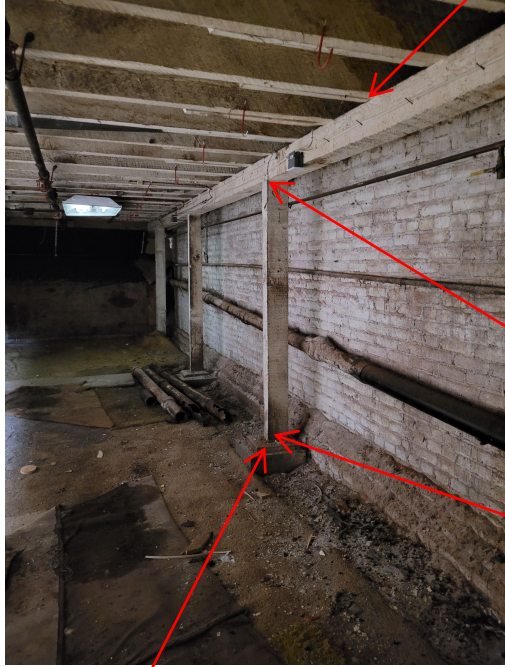
| ITEM | CODE | SCOPE | FIX | COST |
|---|---|---|---|---|
| GROUND FLOOR<br>SUPPORT FRAMING | VMC 17.32.040 F<br>(ITEM F.4 IN REPORT) | <div><p>23% OF THE GROUND FLOOR</p></div> | <div><p>REPLACE POSTS AND SHORES IN THIS AREA. RE-FRAMING WITH 8x8 DF-L POSTS AND 2-FT SQUARE CONCRETE PADS.</p><p>(3) ROWS OF (E) SUPPORT FRAMING WITH REINFORCING CONNECTIONS PER SKETCH</p><p>CLIP TO EA JOIST</p><p>REINFORCING COLUMN CAP TO BEAM CONN, TYP</p><p>REINFORCING COLUMN BASE CONNECTION, TYP</p><p>(4) POST-INSTALLED ANCHORS TO THE (E) CONC BASE, TYP</p><p>REINFORCING SKETCH FOR NORTH WALL (MIDDLE ROW AND SOUTH WALL SIMILAR)</p><div></div><div></div></div> | \$325,000.00 |

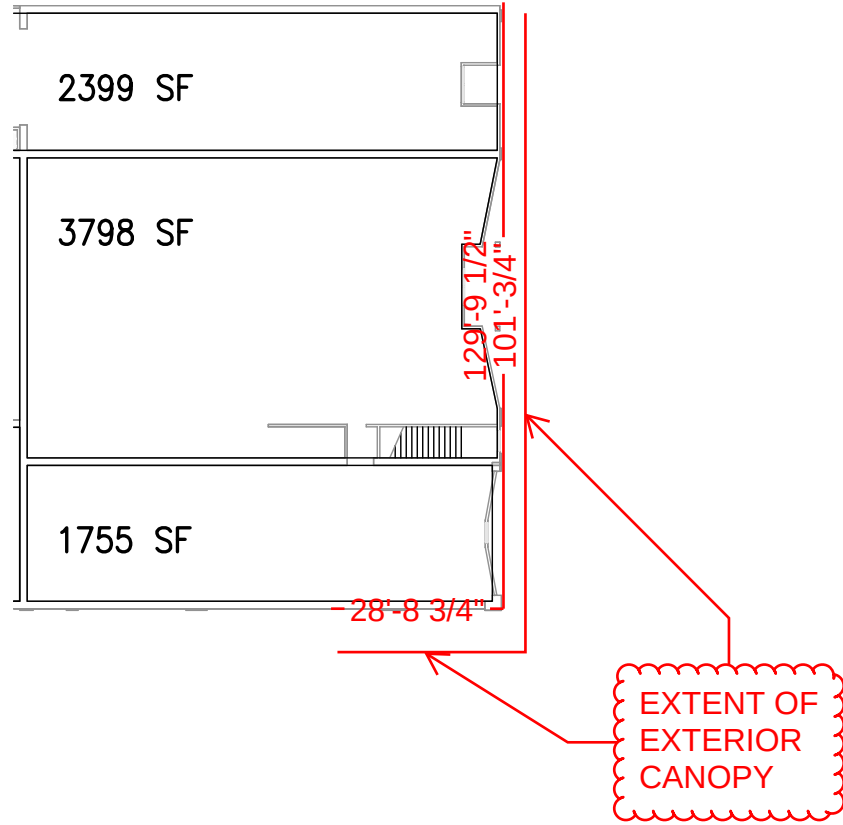
| ITEM | CODE | SCOPE | FIX | COST |
|---|---|---|---|---|
| EXTERIOR CANOPY | VMC 17.32.040 F<br>(ITEM F.5 IN REPORT)<br><br>VMC 17.32.040 G<br>(ITEM G.4 IN REPORT) | | REMOVE AND REPLACE | \$180,000.00 |

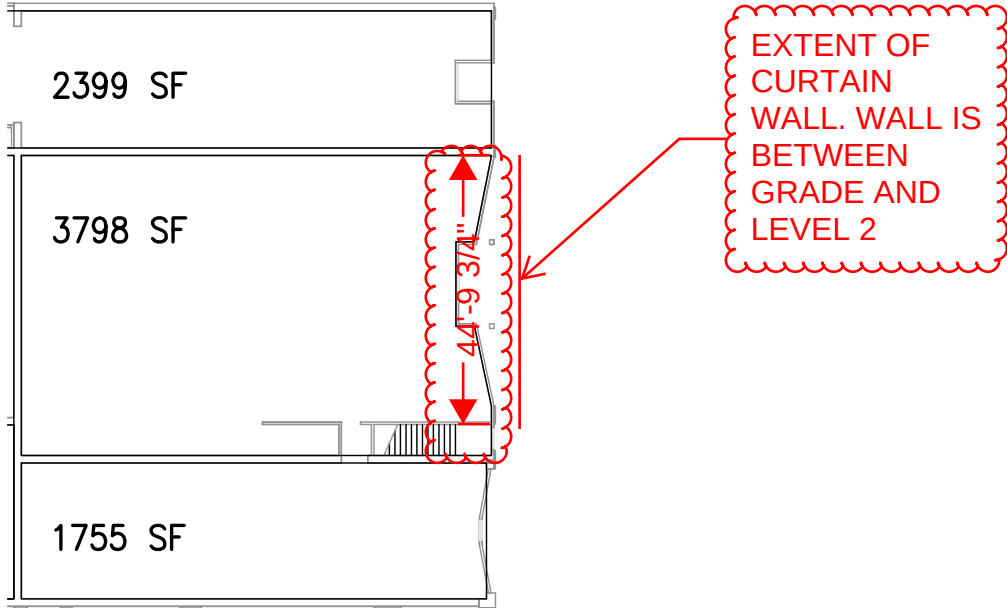
| ITEM | CODE | SCOPE | FIX | COST |
|---|---|---|---|---|
| CURTAIN WALL ALONG MAIN STREET | VMC 17.32.040 F<br>(ITEM F.6 IN REPORT)<br><br>VMC 17.32.040 G<br>(ITEM G.5 IN REPORT)<br><br>VMC 17.32.040 I<br>(ITEM I.3 IN REPORT)<br><br>VMC 17.32.040 K<br>(ITEM K IN REPORT) | | REMOVE AND REPLACE | \$42,575.00 |

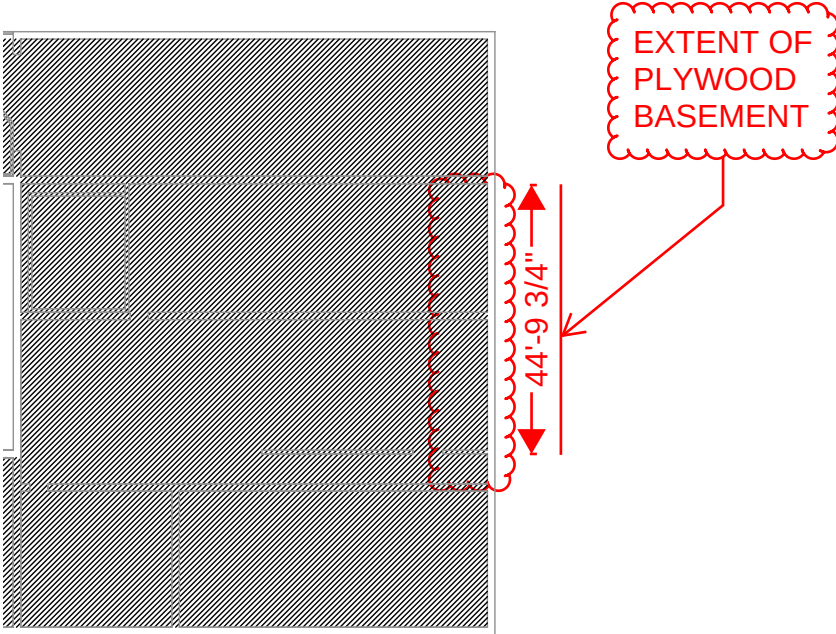
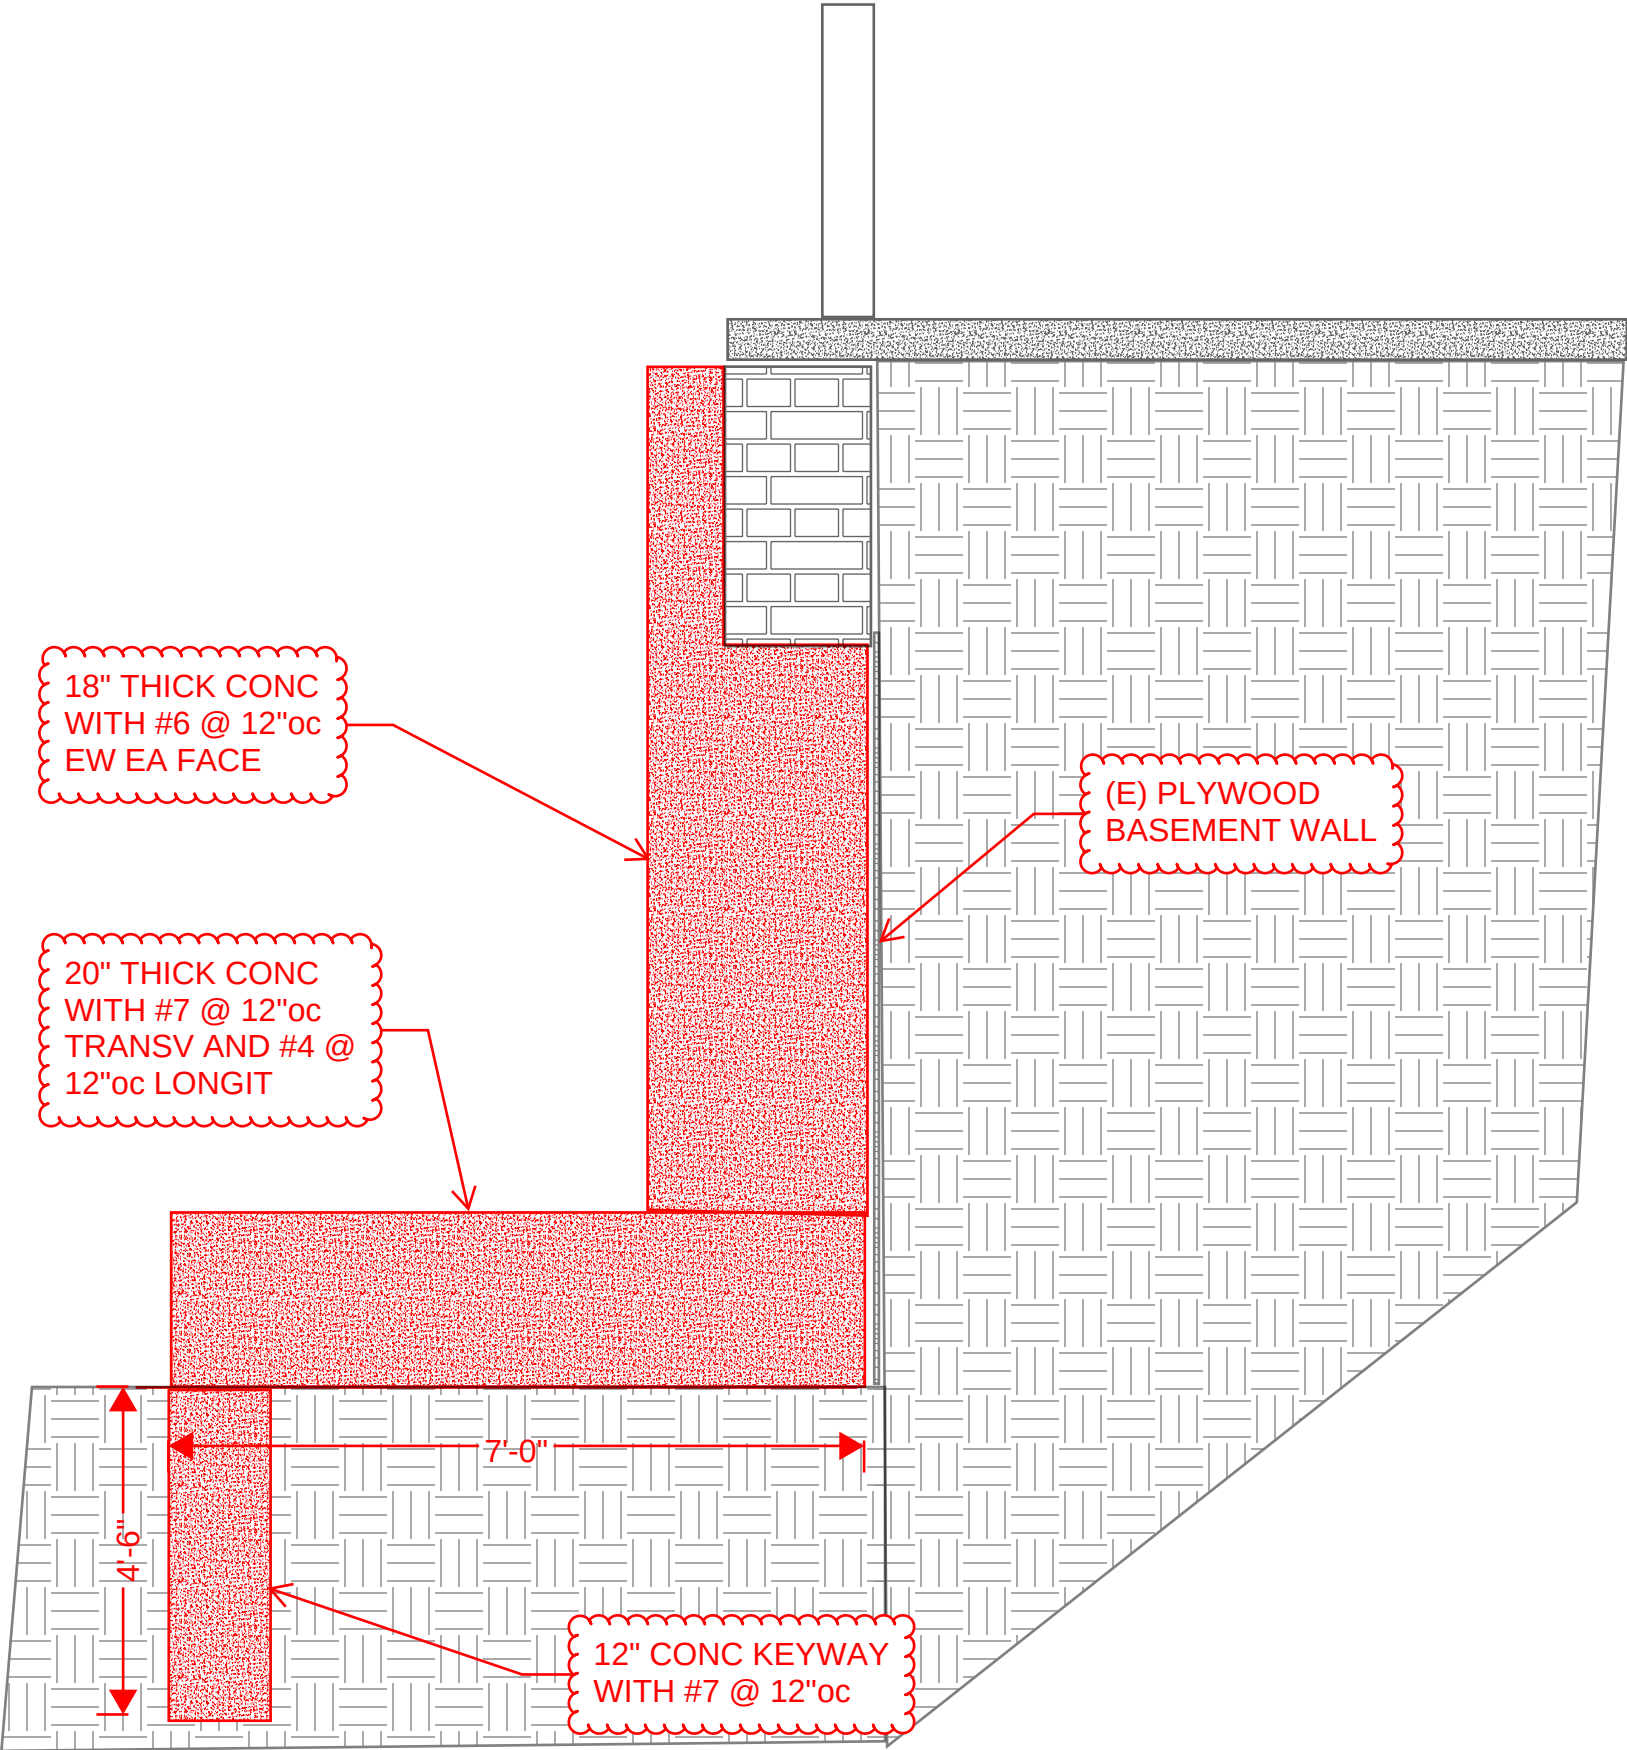
| ITEM | CODE | SCOPE | FIX | COST |
|---|---|---|---|---|
| PLYWOOD BASEMENT WALLS | VMC 17.32.040 I<br>(ITEM I.4 IN REPORT) | | | \$89,000.00 |
