**Staff Report to the Building Fire Code Commission  
Schofield Building-600 Main Street  
Owner's request for unfit determination and demolition per VMC 17.32**

<b>Report Date</b>	October 28, 2024
<b>Hearing Date</b>	October 30, 2024
<b>Buildings/Location</b>	600-604 Main Street. Parcel ID 47950000
<b>Property Owner</b>	Schofield Properties 600 Main St LLC
<b>Staff</b>	Sree Thirunagari, Building Official Jeri Newbold, ABO/Code Compliance Manager Lauren DiPalma, Plan Review Supervisor/Staff Engineer
<b>Applicable codes</b>	VMC Chapter 17.32 Unfit Buildings and Premises Code VMC Chapter 20.510 Heritage Overlay District- demolition process and steps

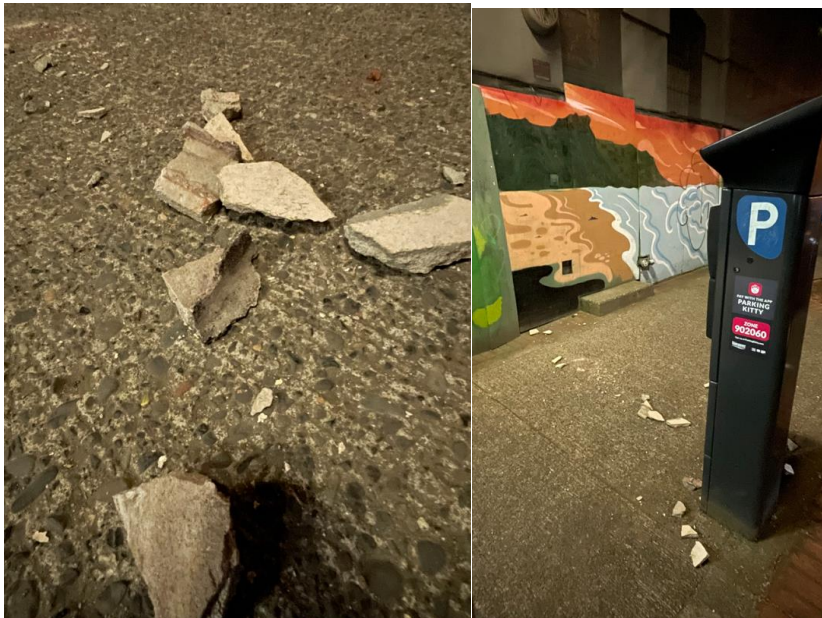
City of Vancouver Code Compliance was copied on an email from the Chief Building Official, Sree Thirunagari on Thursday 4/25/24 regarding the building located at 600 Main Street. Some loose plaster from the chimney had fallen on the sidewalk on 4/23/24 and was reported to the City of Vancouver.

A code case was opened (CDE-89087) but at this time the Chief Building Official had already contacted representatives for the building and instructed them to remove all loose plaster and install netting around the chimney to prevent any further incidents until a more detailed evaluation could be made.

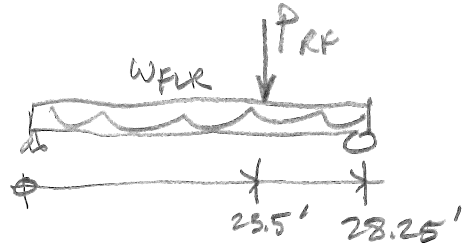
1 5/8" x 1 1/2" joists @ 16" oc  $F_b = 1500 \text{ psi}$  ASSUMED BASELINE

LL	I.E.	w/ $C_D = 1.0$
40 PSF	1.81	FLEXURE
50 PSF	2.07	F
80 PSF	2.84	F
0 PSF	OK (0.86)

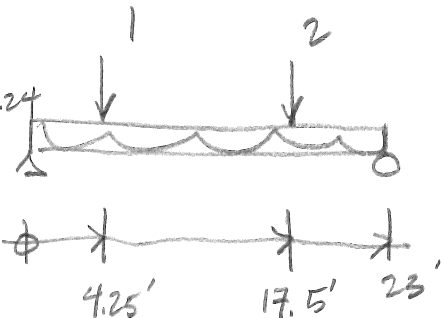
1 5/8" x 11 1/2" @ 16" oc  $F_b = 1500 \text{ psi}$

LL	IE.
40	OK (1.20)
50	OK (1.37)
80	1.88 FLEXURE
0	OK (0.57)

0.75 (LL+SL)	IE.
30 PSF	OK (1.36)
37.5	OK (1.47)
60	1.80 F
0	OK (1.00)

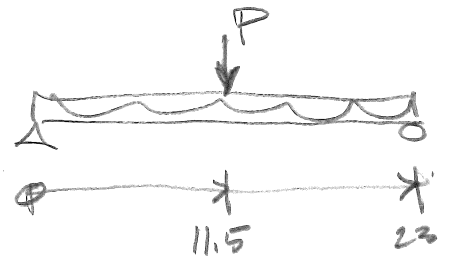
0.75 (LL + SL)	IE
30	OK (1.43)
37.5	1.54 FLEXURE
60	1.87 F
0	OK (1.08)
