## Building/Fire Code Board Meeting Agenda

# SCHOFIELD BLOCK

BUILDING AND FIRE CODE COMMISSION MEETING

## STAFF REPORT

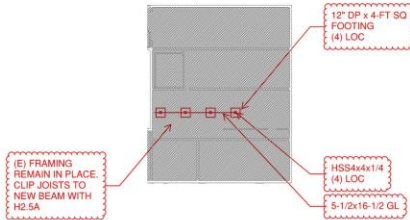
<br><br>18% OF THE GROUND FLOOR<br>100 PSF LIVE LOAD |

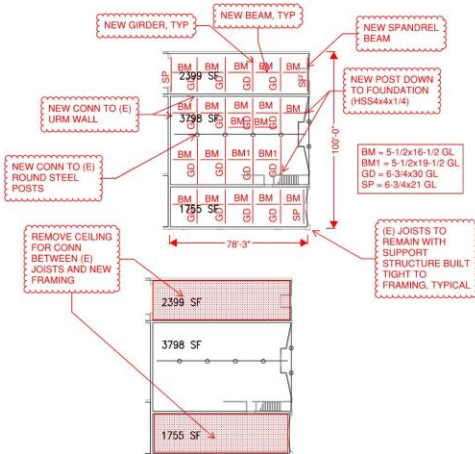
| ITEM | CODE | SCOPE | FIX | COST |
|---|---|---|---|---|
| SECOND FLOOR FRAMING CAPACITY | VMC 17.32.040 C<br>(ITEM C.2 IN REPORT)<br><br>VMC 17.32.040 I<br>(ITEM I.2 IN REPORT) | <div></div> <p>93% FLOOR FRAMING</p> <p>50PSF LIVE LOAD OFFICE OCCUPANCY</p> | <div></div> | \$441,489.00 |

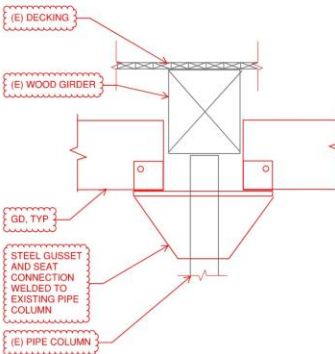
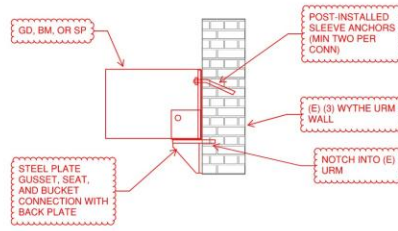
| ITEM | CODE | SCOPE | FIX | COST |
|---|---|---|---|---|
| <div><div><p>TYP GIRDER TO (E) STEEL PIPE COLUMN</p></div><div><p>TYP BEAM, SPANREL, GIRDER TO (E) URM</p></div><div><p>TYP JOIST TO BEAM<br/>BEAM TO GIRDER/SPANREL</p></div></div> | | | | |

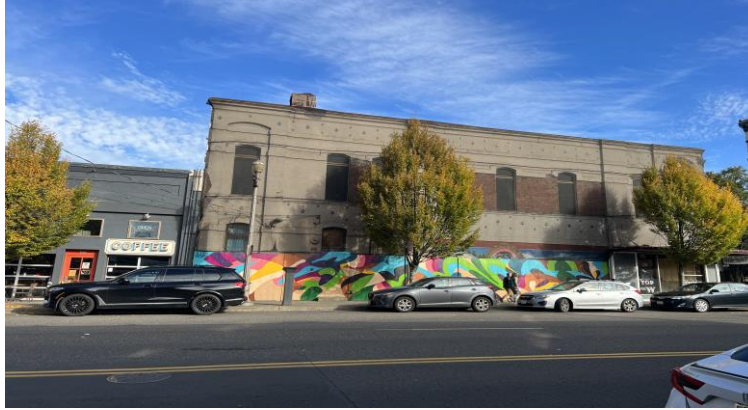
Sixth Street Elevation-Picture date 10/25/2024

The south section of the two-story Schofield building is considered the original portion constructed around 1880.

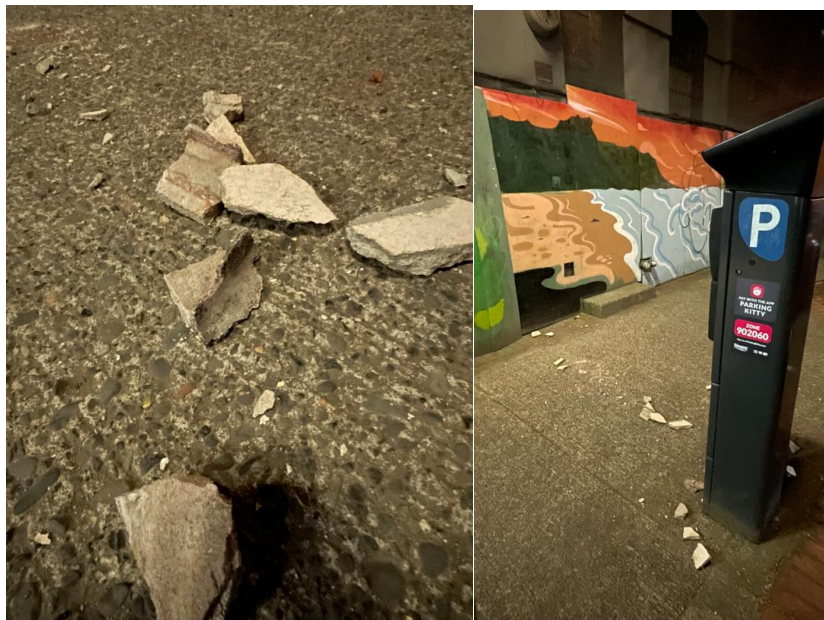
City of Vancouver Code Compliance was copied on an email from the Chief Building Official, Sree Thirunagari on Thursday 4/25/24 regarding the building located at 600 Main Street. Some loose plaster from the chimney had fallen on the sidewalk on 4/23/24 and was reported to the City of Vancouver.

A code case was opened (CDE-89087) but at this time the Chief Building Official had already contacted representatives for the building and instructed them to remove all loose plaster and install netting around the chimney to prevent any further incidents until a more detailed evaluation could be made.

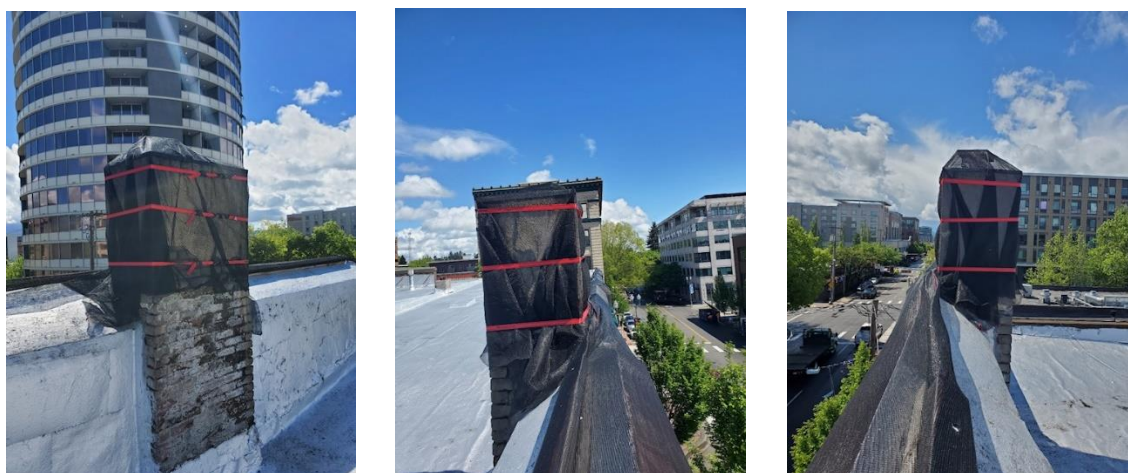
(Photos from email on 4/29/24)

Code compliance received an email from April Velilla on Monday 4/29/24 indicating the work has been completed and photos were attached.

After reviewing the photos with the Chief Building Official, it was determined that the code case would be closed and the building owners would be meeting with city staff to determine the next steps.
